## Heisler #3 Water Tank Repairs

The following information was extrapolated from Facebook posts in whole or in part.

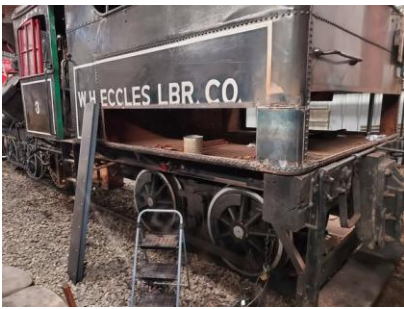
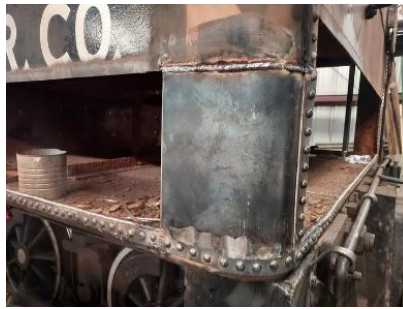
### January 22, 2025: Two separate posts included the first two photos.

Eric Wunz posted *“Mr. Tholen has started welding in the new pieces on the #3s water tank. Looking good. Not easy accurately replicating the historical appearance, appreciate his efforts to do so”*.

Jim Grigsby wrote *“We talked about keeping the historic dent in this corner, but it would have been too complicated. We don't know the story of the dent but it was there when #3 came back from Idaho”*.

Taylor Rush responded *“I think she got the big corner dent when she rolled on her side into the creek in the 1920s”*.

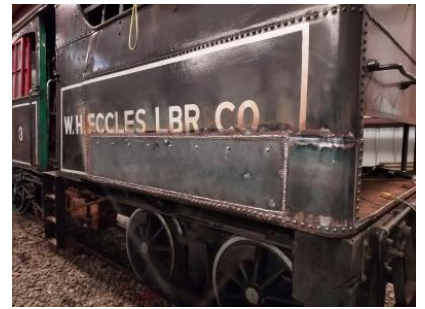
### February 9, 2025: Included the third photo.

Eric Wunz posted *“More steel has been welded in the #3s water tank. Good job replicating the rivets”*.

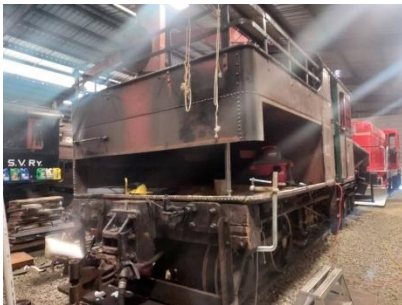
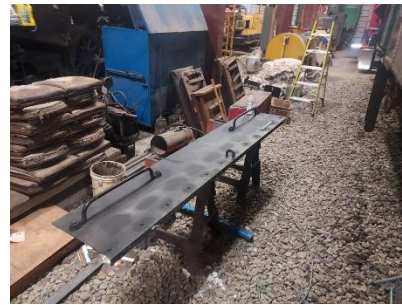
### February 14, 2025: Included the photos below.

Eric Wunz posted *“More work happening on the Heisler; other corner removed and the back large piece is fabricated and on site”*.

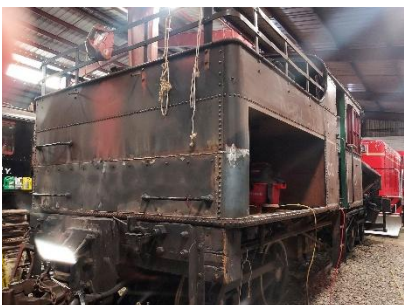
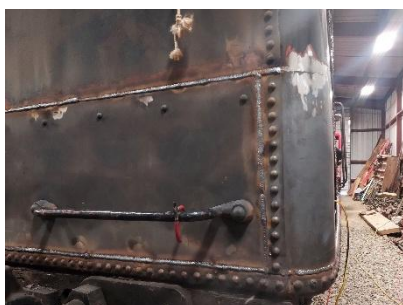
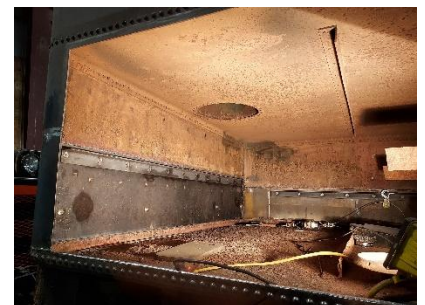
### February 23, 2025: Included the next three photos.

Eric Wunz posted *“Progress on the #3 water tank. More bracing to be installed on the inside”*.

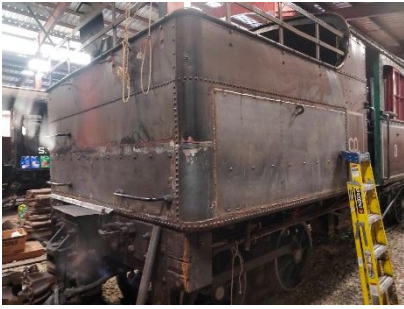
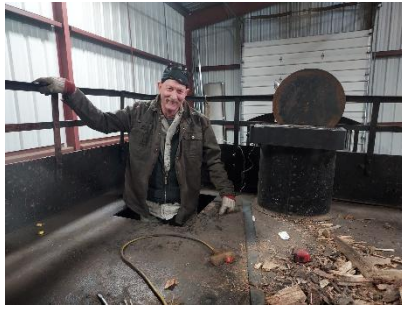
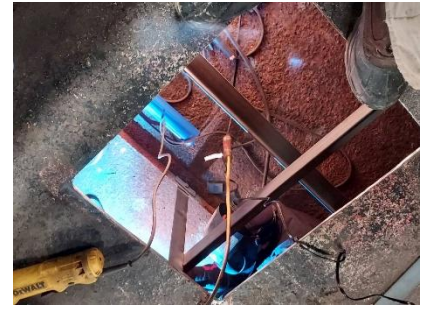
**March 10, 2025: Included the following three photos.**

Eric Wunz posted *"Doni was up today, last side piece is welded in and he is working on the internal bracing. Had to cut an access and ventilation hole and we agreed to keep it for future access. The lid will bolt down so it can be opened up as needed. With the internal bracing in it is a tight squeeze inside"*.

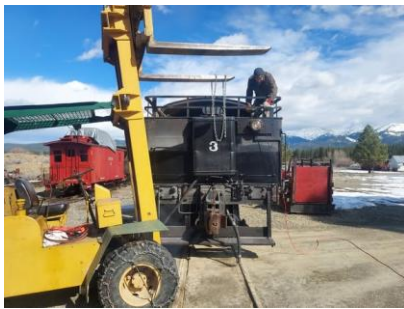
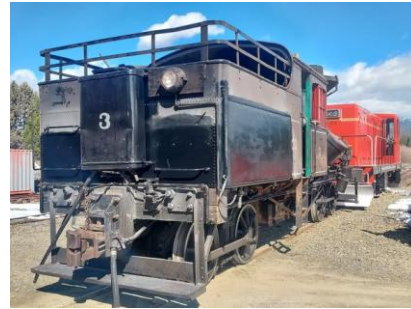
**March 27, 2025: Included the two photos on right.**

Eric Wunz posted *"We were able to hang the rear sand box on the Heisler today. Doni got it bolted on and all that is left is to paint and letter. I appreciate all his work on this and it is looking great"*.

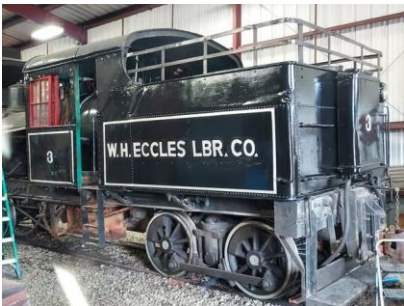
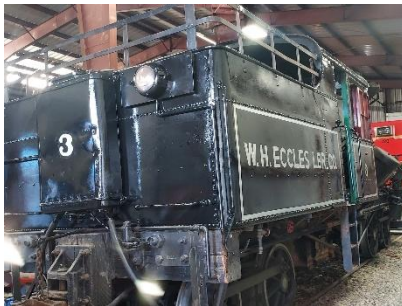
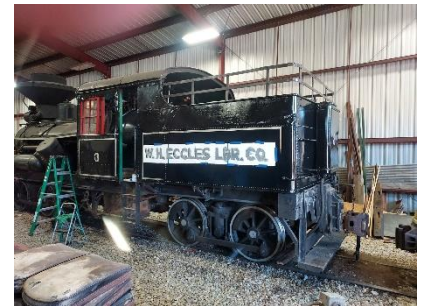
**April 6, 2025: Included the next three photos.**

Eric Wunz posted *"Heisler cab sides and water tank are painted and lettered. I traced the lettering before work started and cut the stencil to that, so it is the same as before"*.

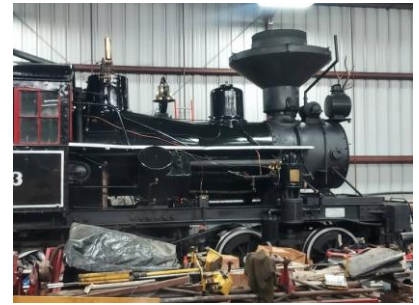
**May 17, 2025: Included the single photo at right.**

Eric Wunz posted *"Rainy day on Sat so did some painting on the Heisler, including the smokebox and stack with high temp paint"*.

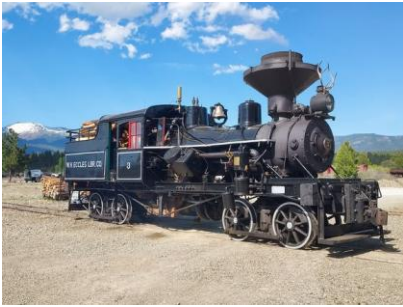
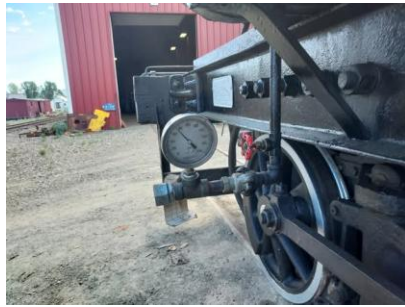
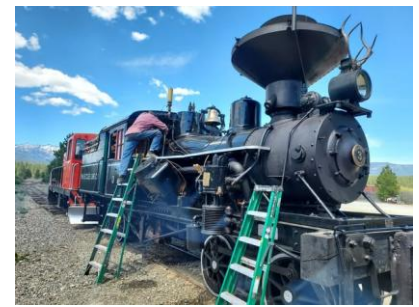
**May 28, 2025: Included the three photos below.**

Eric Wunz posted *"Many thanks for Tom Young driving over to help out on the #3. Passed orifice test (air compressor output) and got some of the steam leaks fixed. Still some leaks at the injectors and the brake stand needs an internal cleaning as it is not acting correctly. I will be back tomorrow to hopefully address the above issues"*.

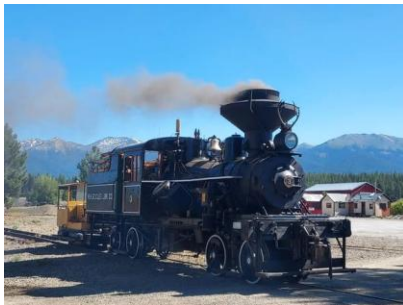
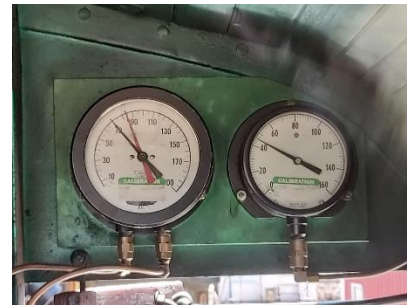
**June 9, 2025: Included the next two photos below.**

Eric Wunz posted *"Found my book on A-1 brake systems and worked some more on the Heisler's brake stand. Fired it up to run the air compressor and tested it with the train consist. Some more adjustments and now acting properly. Still has an extended blow at the brake stand in lap after reducing brake pipe pressure that does not affect functionality"*.
